The Tower Restoration

Tower Restoration Project

Now, the tower needs our help. Assessment by the firm of Criteriu-Bennett Engineers has revealed that the toll of age and weather on structural components needs to be addressed to prevent further damage.

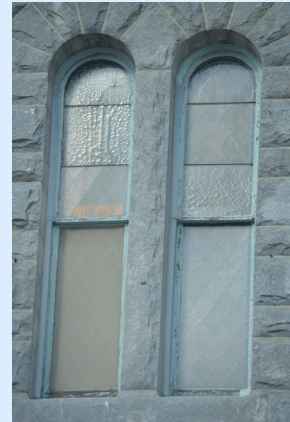
Repair stained glass windows

* **Condition:** Defective/missing glazing, deteriorated lead joints and water infiltration around frames.

Original 23 windows and frames removed in October 2020 by Serpentino Stained Glass.

* **Work:** Repair leaded glass, replace/repair rotted frame and sash components, apply architectural caulk and install aluminum sash protectors. Windows will be reinstalled in spring of 2021.

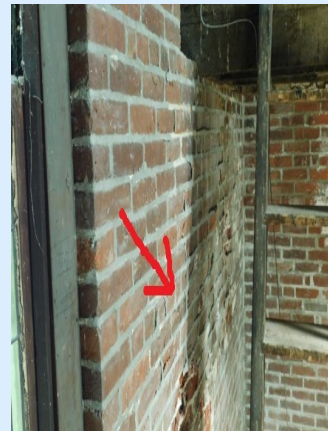
Repair, repoint and caulk masonry above bell deck

* **Condition:** Interior brick tower (mostly original bricks) has eroded mortar joints and some brick cracking where water has penetrated. Wet bricks fail due to freeze/thaw cycles.

* **Work:** Replace Portland mortar with lime mortar to allow moisture to wick through mortar and not the bricks.
